SPECIAL REPORT ON ANADROMOUS STREAM SURVEYS OF CLEVELAND
PENINSULA, INCLUDING EMERALD BAY, VIXEN INLET, UNION BAY,
CLARENCE STRAIT, BOND BAY, SPACIOUS BAY, AND PORTIONS OF
PORT STEWART AND HELM BAY

Subdistricts 107-10 and 102-80

March 1985

Alaska Department of Fish and Game
Division of Commercial Fisheries
Petersburg, Alaska

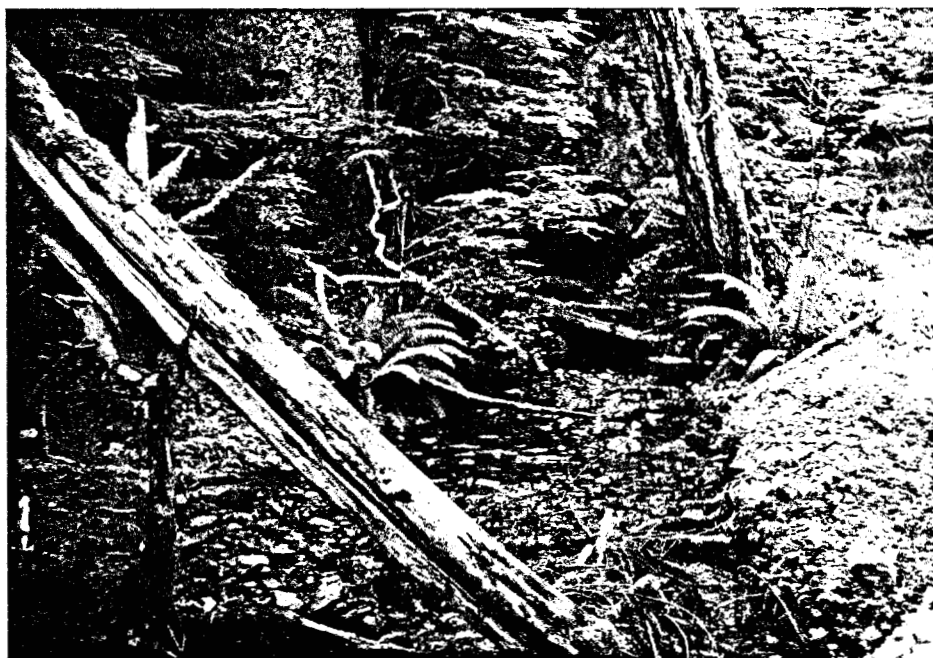
2. Section 1: The gradient increases midway through the Section.

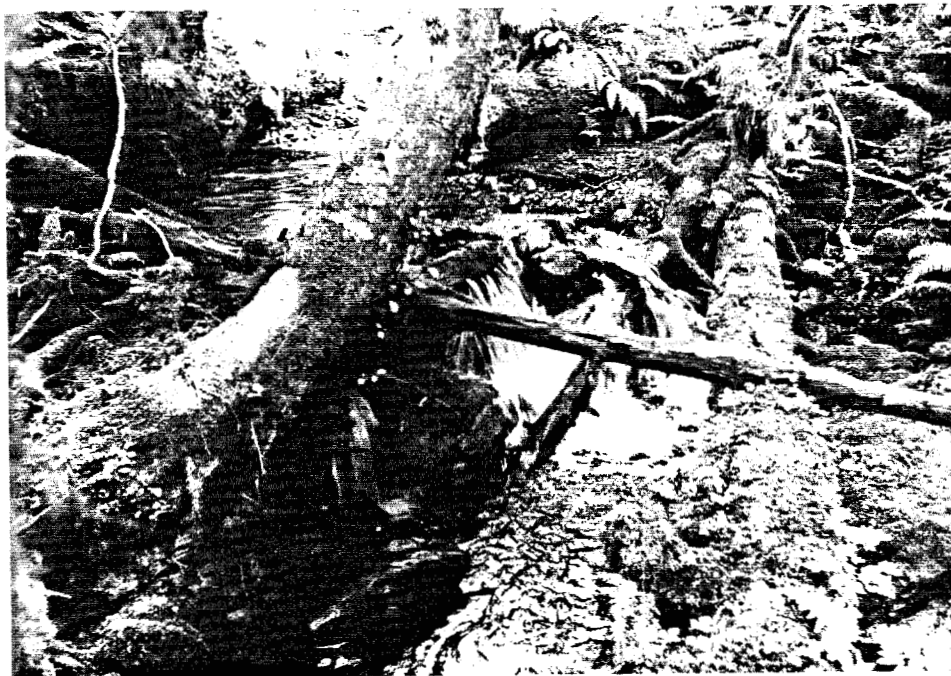
2. Debris obstacle 20 m. into Section 1.

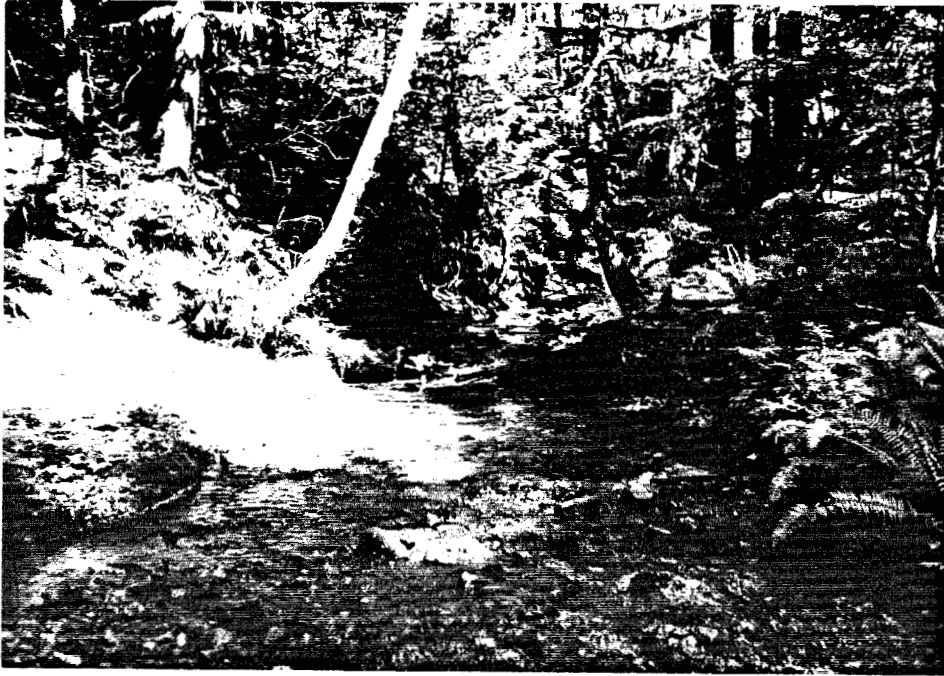
3. Section 1 contains the stream's best ASA.

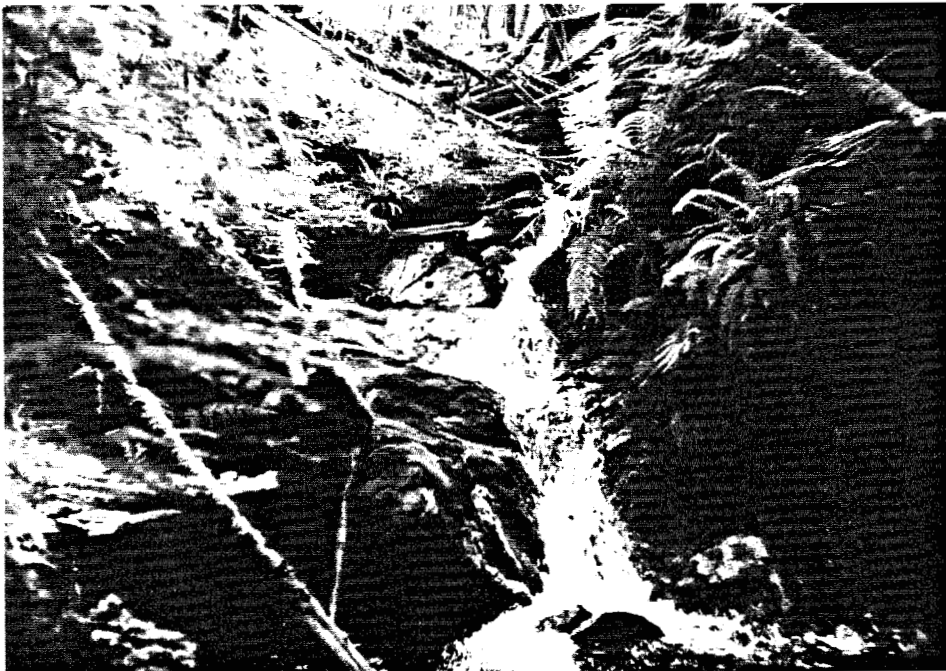
4. End of Section 4: Start of probable barrier.

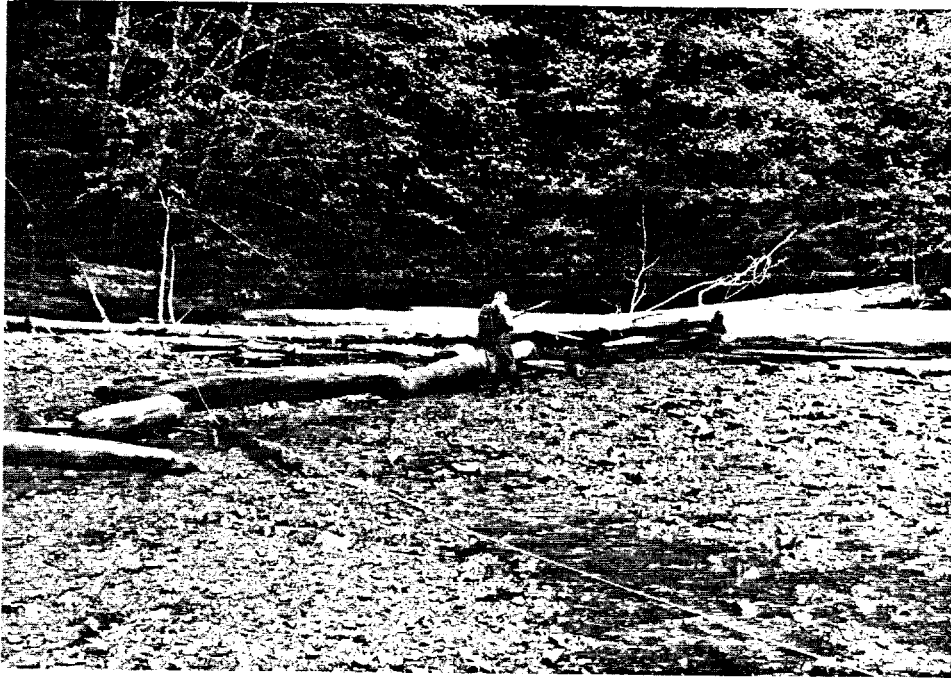
1. Upper ITZ

About 30 m² of good substrate is present in the upper ITZ. The water depth is only 5 cm, however and a moderate to heavy amount of silt is present interstitially. What appears to be a logging road was found running north of the ITZ. Clarence Strait #5 shows signs of having been the site of a large logging operation. An old logging road runs north from the ITZ and the stream itself resembles a road more than a stream. The banks are very uniform, possibly from having logs slide down the streambed. The rearing habitat is poor quality due to a lack of debris, undercut banks, or overhanging riparian vegetation. Suitable substrate for ASA is present, but a high water flow would be necessary to make the substrate accessible to salmon. The stream appears to be intermittent. No rearing fish were observed or captured.

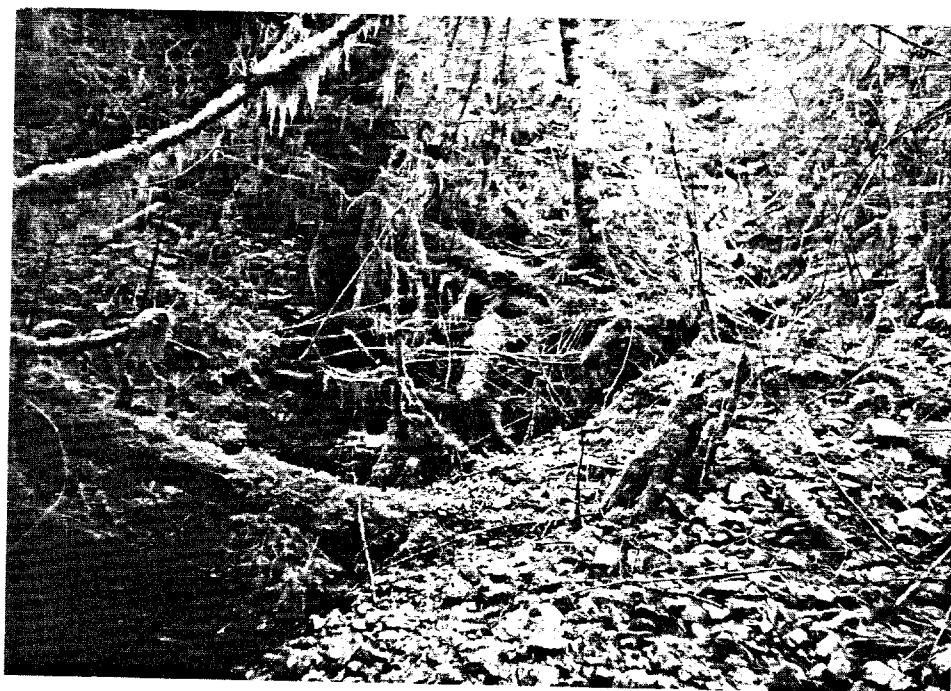
4. Taken 100 m. up left fork.

The left fork continues for about 200 m. before skunk cabbage begins growing in the stream and it appears the stream may be intermittent beyond here. The substrate up to this point is cobble that might possibly be utilized by coho at high flows. The active water width is 1 m., but the channel is 5-10 m. in width. No rearing fish were observed.

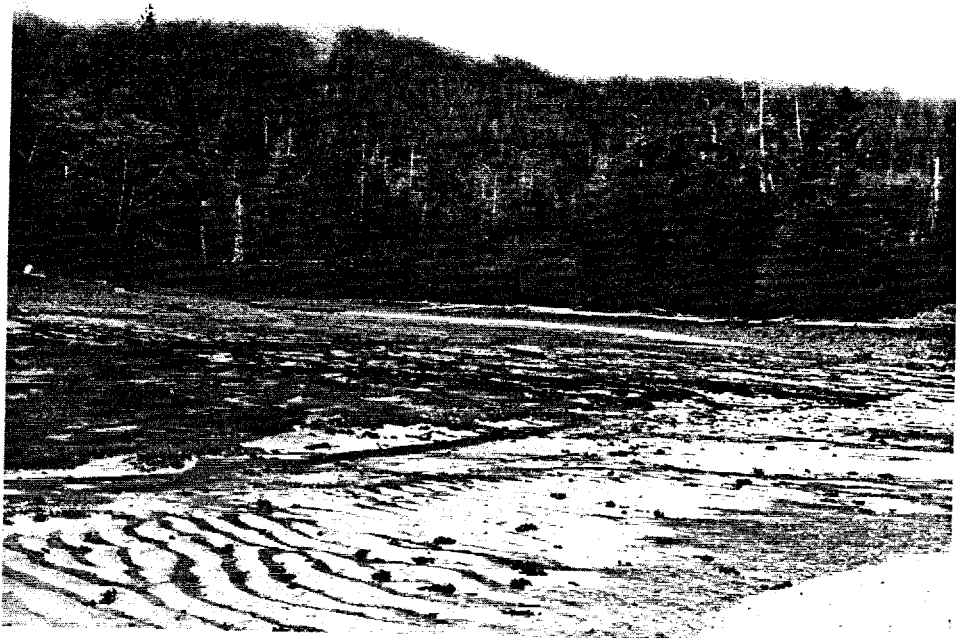
1. ITZ

The upper ITZ contains a 30 m. stretch with usable gravel. The lower ITZ is all sand.
102-80-24 is a small stream that dries up within 500 m. of the beach. The stream is very shallow and more ASA might be available at a higher water stage. The substrate is rather compact, but PS bones were found throughout the survey area. The rearing area is limited by the shallow depth of the stream. No rearing fish were observed or captured.

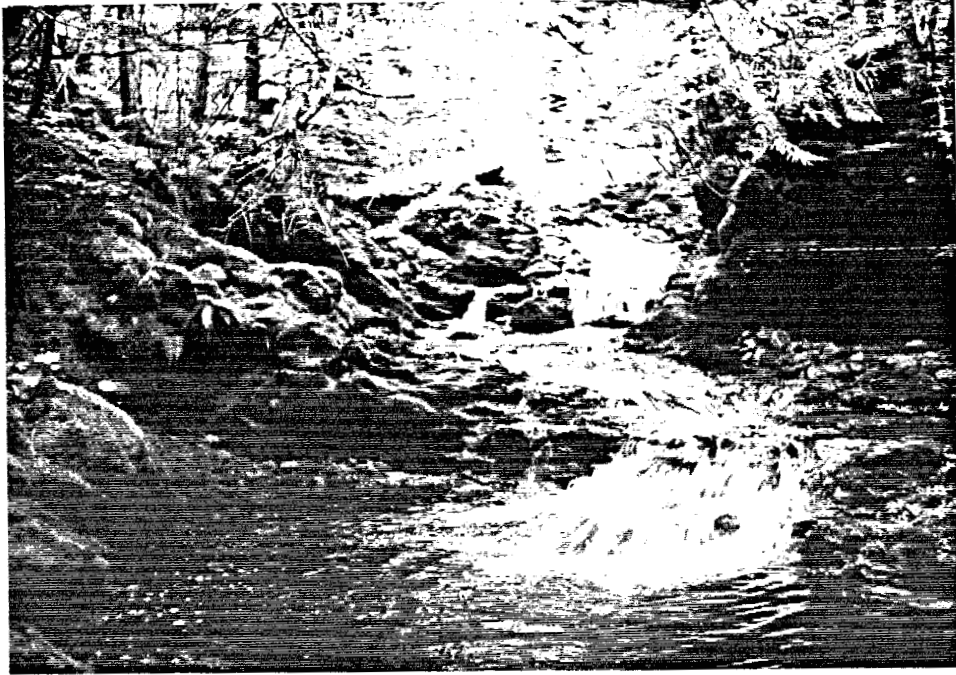
Clarence Strait #6 has very limited fisheries potential. A 3 m. barrier falls is present 75 m. from the beach and at least two more 10 m. falls are present 200 m. further upstream. Only patches at ASA were present in the first 25 m. of the stream. This stretch contained the only good rearing habitat also. The substrate was primarily bedrock and boulders beyond the first 25 m. No rearing fish were observed or captured.

3. Looking at barrier falls over bedrock.
